FIELD INVESTIGATIONS OF UNCONTROLLED HAZARDOUS WASTE SITES

Hydrogeologic Report on the
Federal Marine Terminals Property
Riverview, Michigan
TDD# F5-8007-5C

March, 1982

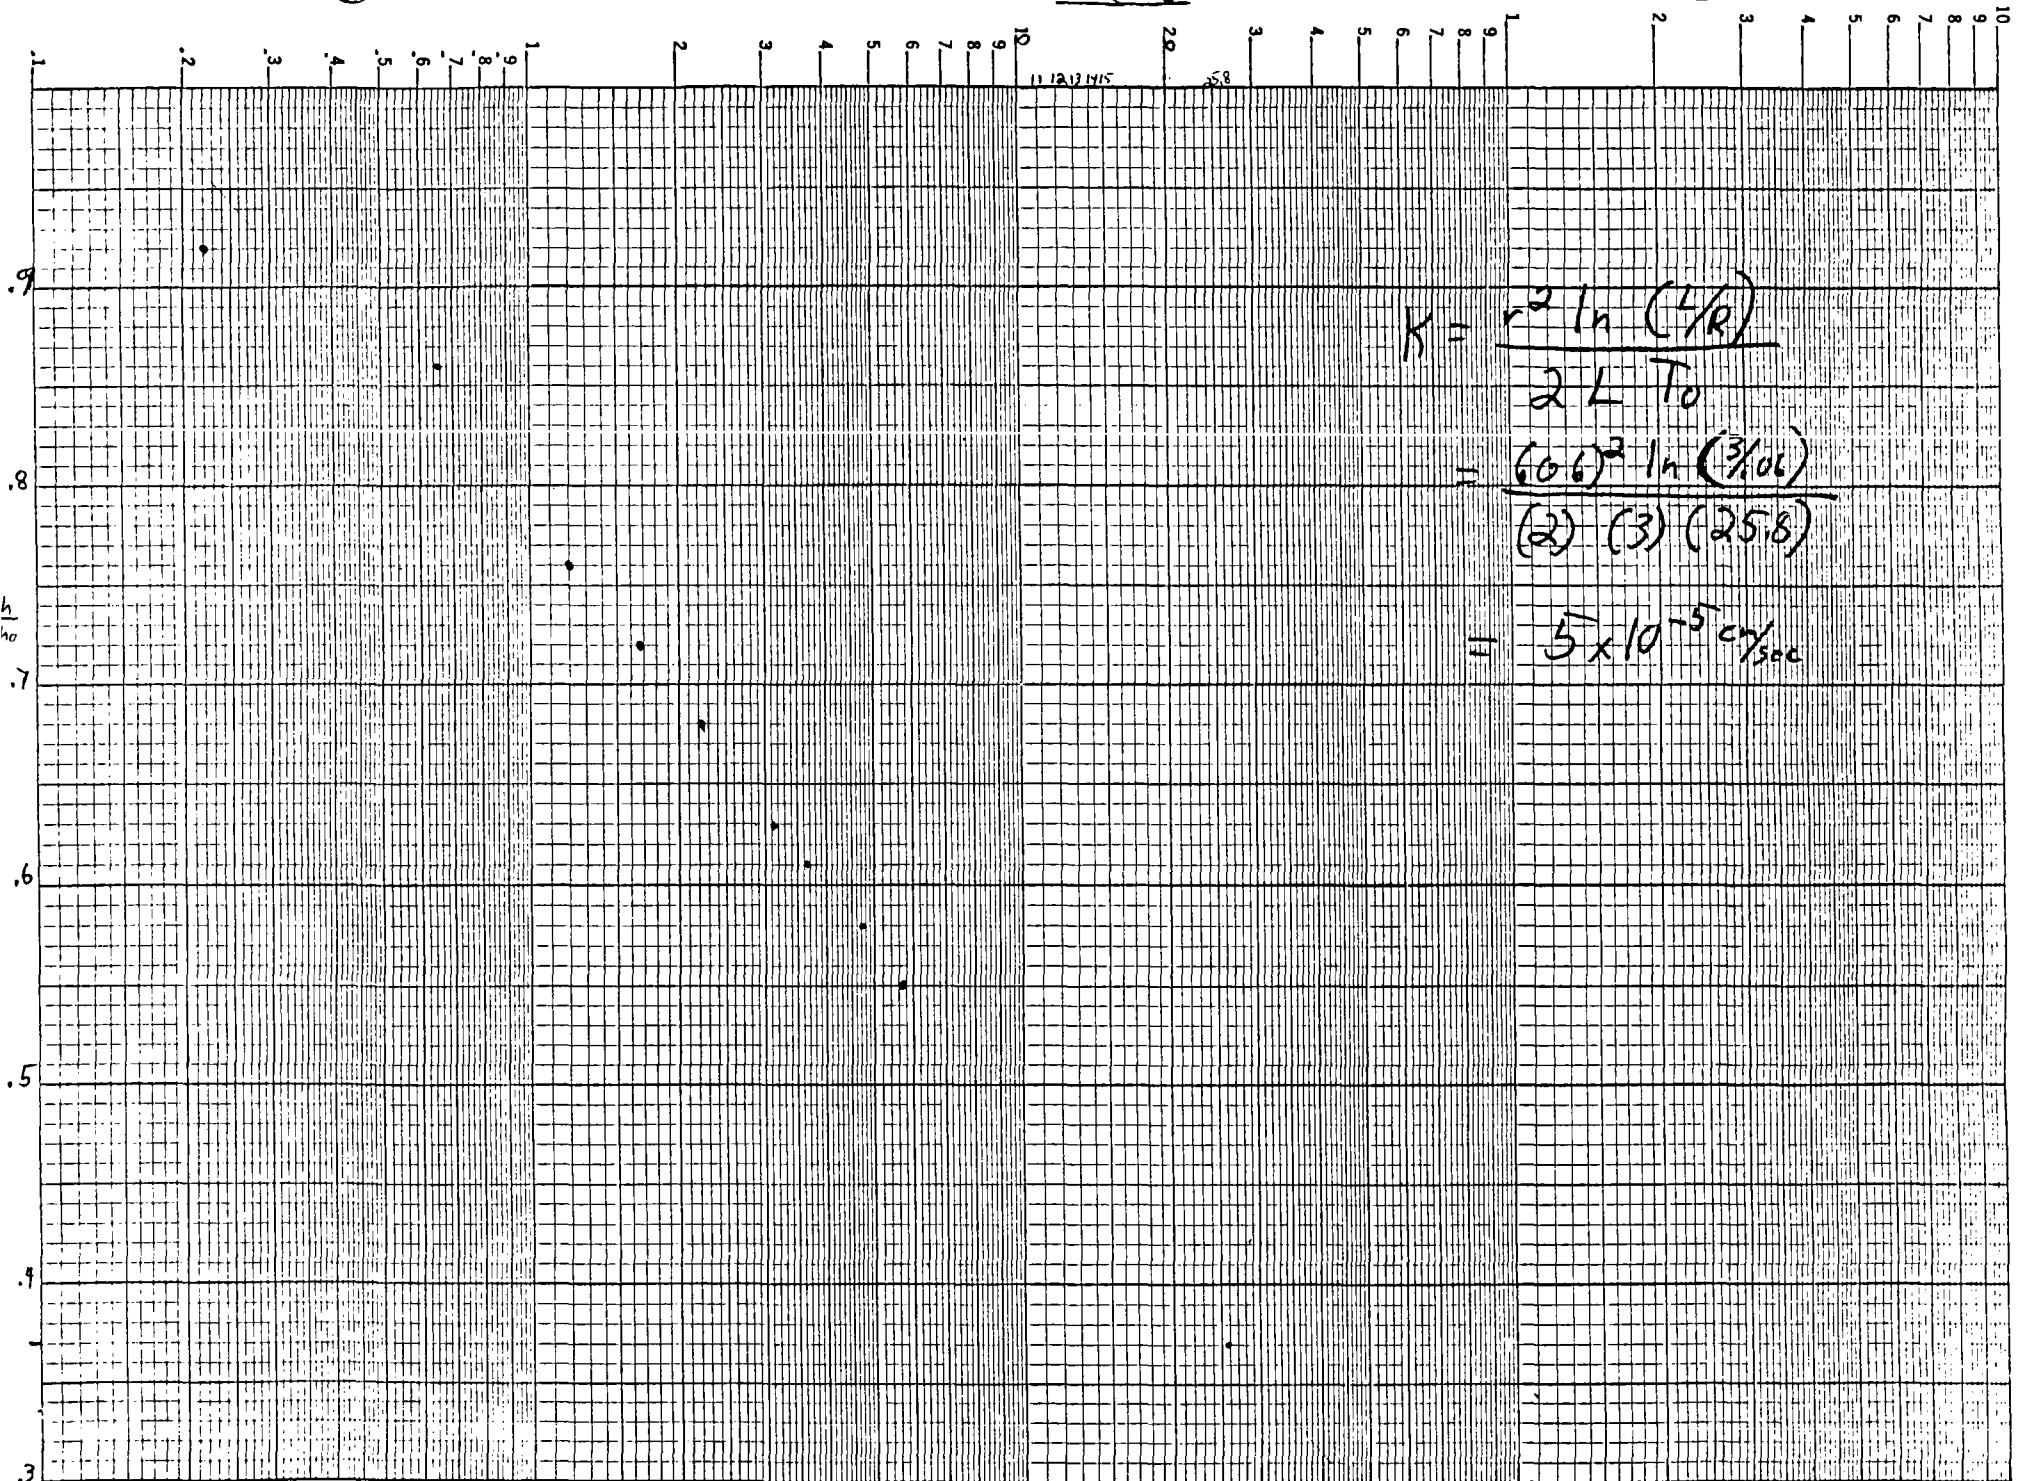
Wall #7 Run #1

$$\begin{aligned}
 K &= \frac{r^2 \ln(L/R)}{2 L T_0} \\
 &= \frac{(6.6)^2 \ln(3/0.6)}{(2)(3)(25.8)} \\
 &= 5 \times 10^{-5} \text{ cm/sec}
 \end{aligned}$$

T - 25.8 minutes

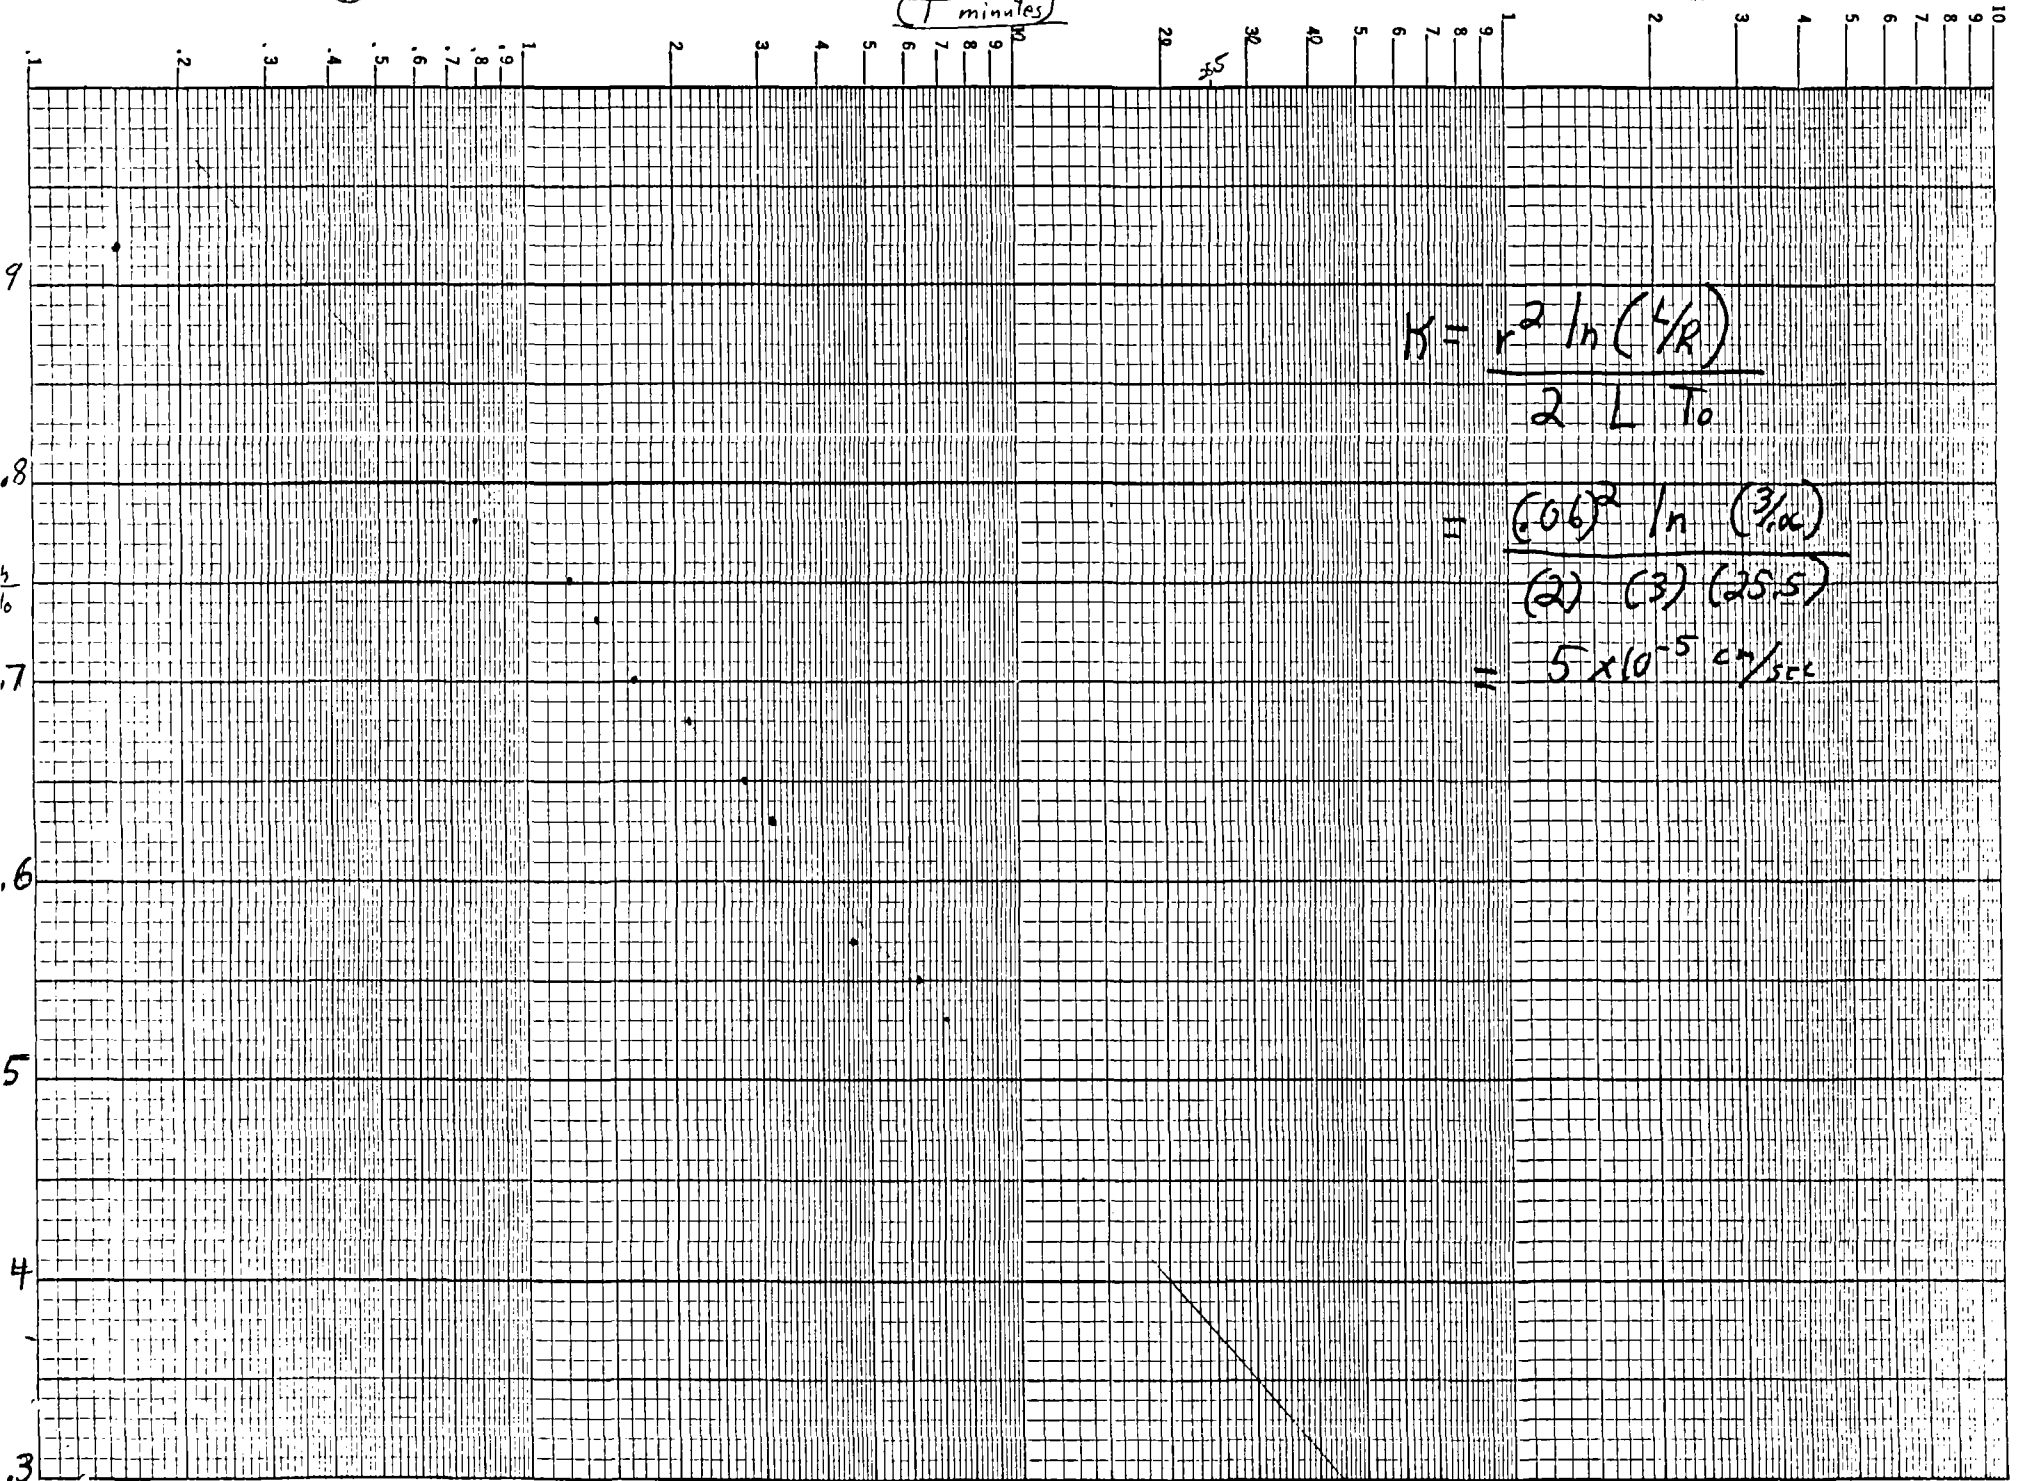
Well #17 Run 2

$$K = \frac{r^2 \ln(L/R)}{2 L T_0}$$

$$= \frac{(0.6)^2 \ln(3/1.6)}{(2) (3) (25.5)}$$
